DATE: 19-Sep-16  
TO: Auto Crane Dealers  
SUBJECT: NexStar III – Remote Trigger Repair

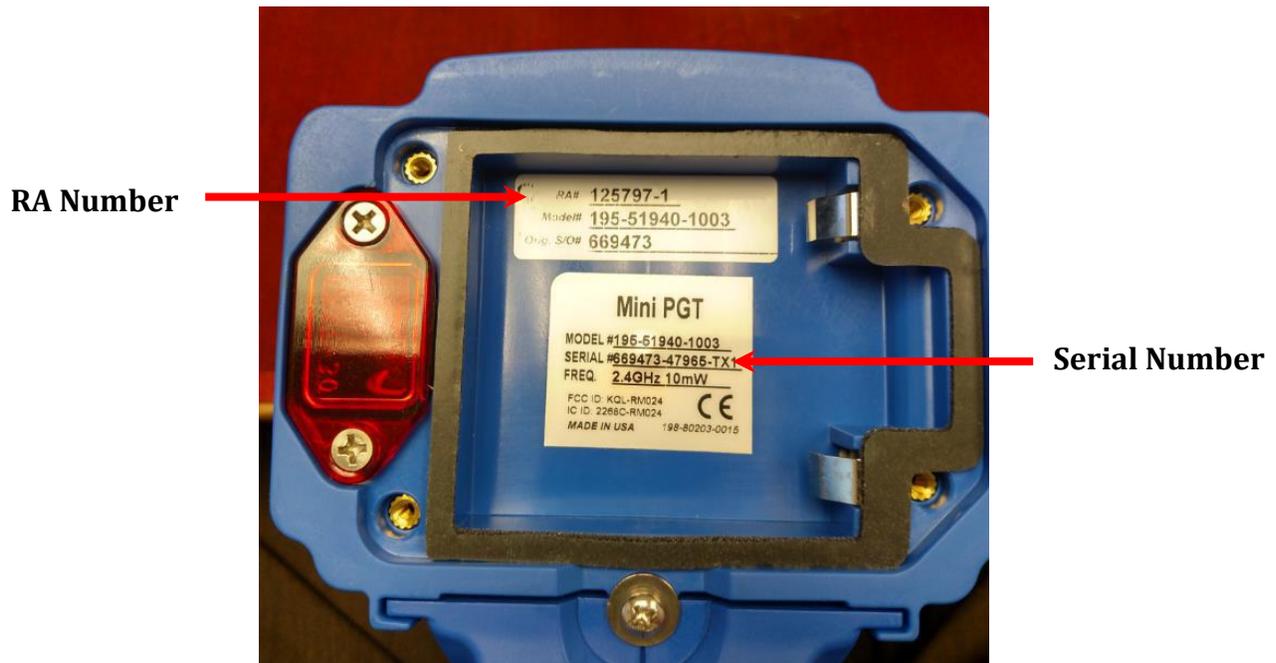
NexStar III remotes manufactured prior to April 2016 have the potential issue where the trigger magnet separates from the plastic trigger. Remotes with RA number less than 125237 may experience this issue. Crane operation will not be possible when the magnet detaches from the trigger.

The magnet-to-plastic trigger adhesion quality was improved as part of the corrective action on remotes with 678366-48257-TX1 or RA 125237 or greater.
